Petrographic Investigation of A Concrete Core Extracted from the Backwall of the US 89 Bridge Over Belt Creek

David Rothstein, Ph.D., P.G., FACI
Report No. 217649.d
2 June 2021

US 89 Over Belt Creek Backwall Core Petrography

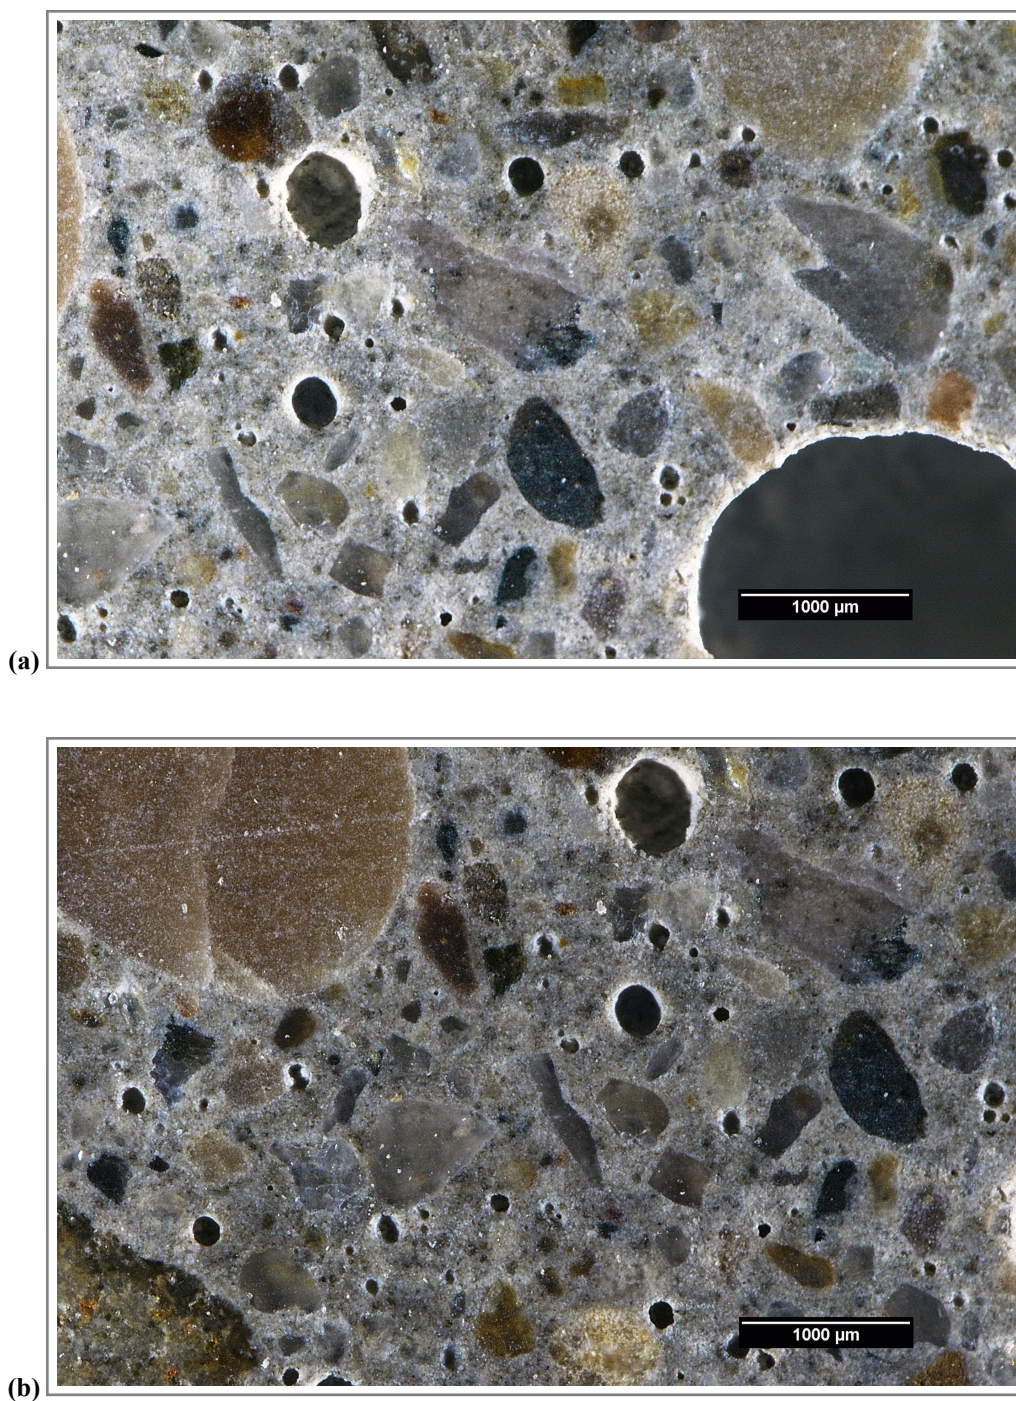
Figure A14. Reflected light photomicrographs of the polished surface showing air voids (dark circles).

- The concrete is marginally air-entrained with 3-4% total estimated air content (**Figure A14**). The concrete is well consolidated with no major water voids or consolidation voids observed.

VOID SYSTEM	The concrete is marginally air-entrained with 3-4% total estimated air content (Figure A14). No significant water voids or consolidation voids were observed.
VOID FILLINGS	Voids commonly contain deposits of ettringite and occasionally contain deposits of ASR gel.

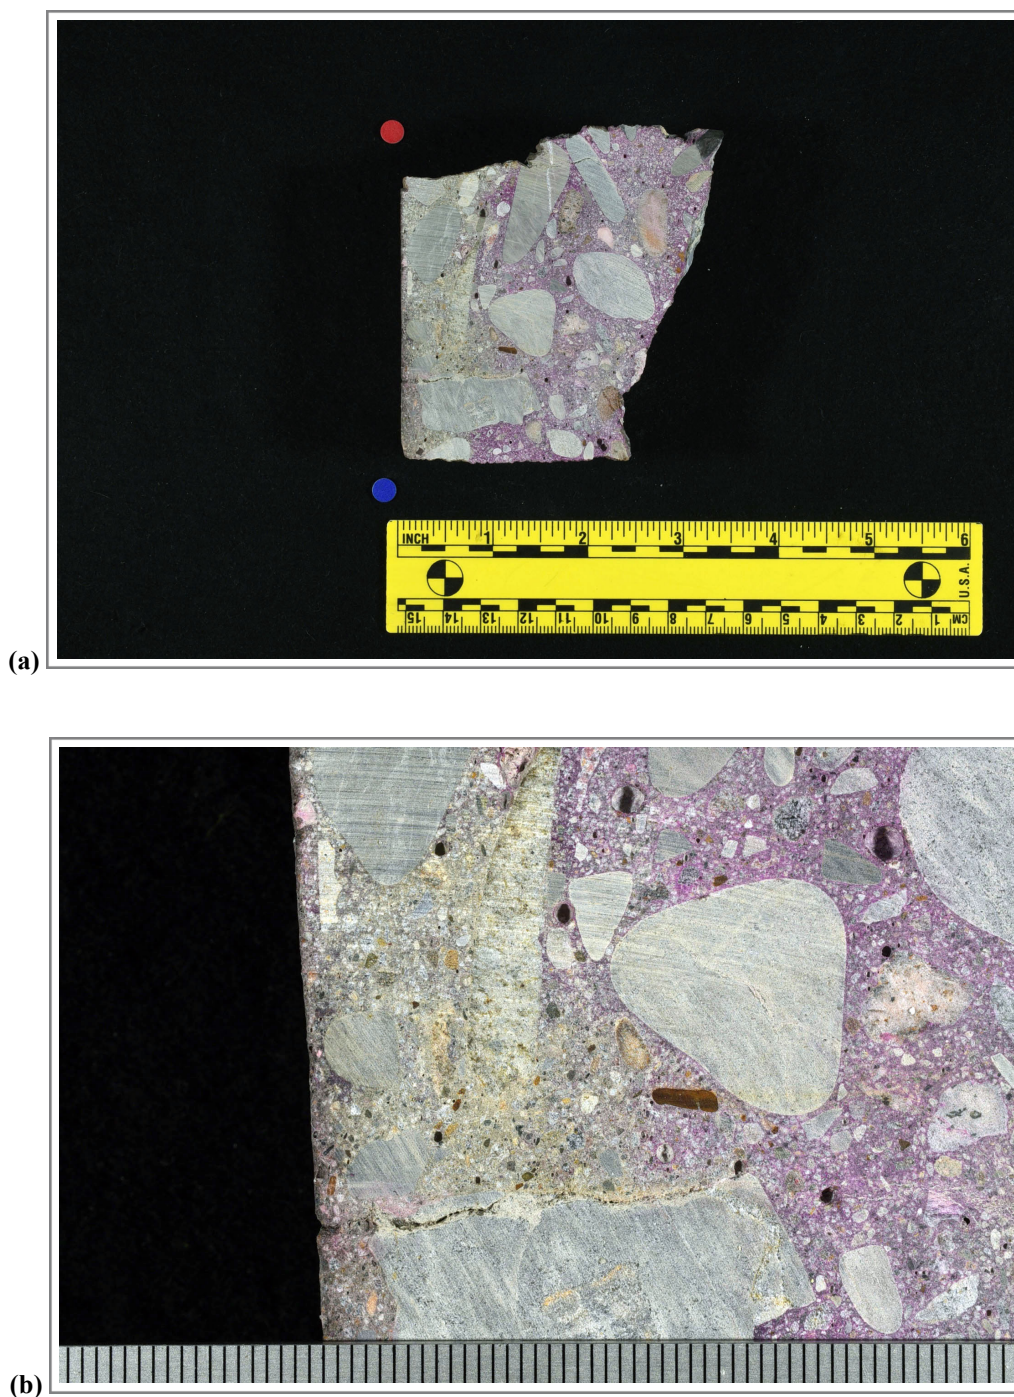
Figure A15. Photographs showing (a) overview of phenolphthalein-stained surface and (b) detail of surface near the outer surface of the core. The yellow scale in (a) is ~ 150 mm (6 in.) long; the small and large divisions are in centimeters and inches, respectively. The scale in (b) is in millimeters.

- Secondary deposits consists of calcium carbonate, ettringite and ASR gel. Carbonation was observed for up to 15 mm (⅝ in.) from the outer surface (**Figure A15**). Deposits of ettringite were occasionally observed in voids inboard of the carbonated zone (**Figure A16**). SDeposits of ASR gel were observed in voids, cracks and microcracks and around aggregate particles (**Figure A5-Figure A7; Figure A17**). The core shows it is in Stage IV using the qualitative scale of Katayama [1] with moderate to severe damage from ASR using the DRP scale. The ASR primarily involves limestone, quartzite and granitic rocks in the coarse and fine aggregate.

PHENOLPHTHALEIN	No staining for up to 15 mm (⅝ in.) from the outer surface (Figure A15).
SECONDARY DEPOSITS	Deposits include pervasive carbonation in the outer 15 mm (⅝ in.), deposits of ettringite in air voids inboard of the carbonated zone (Figure A16) and deposits of ASR gel in microcracks, air voids and rimming aggregate particles (Figure A17).

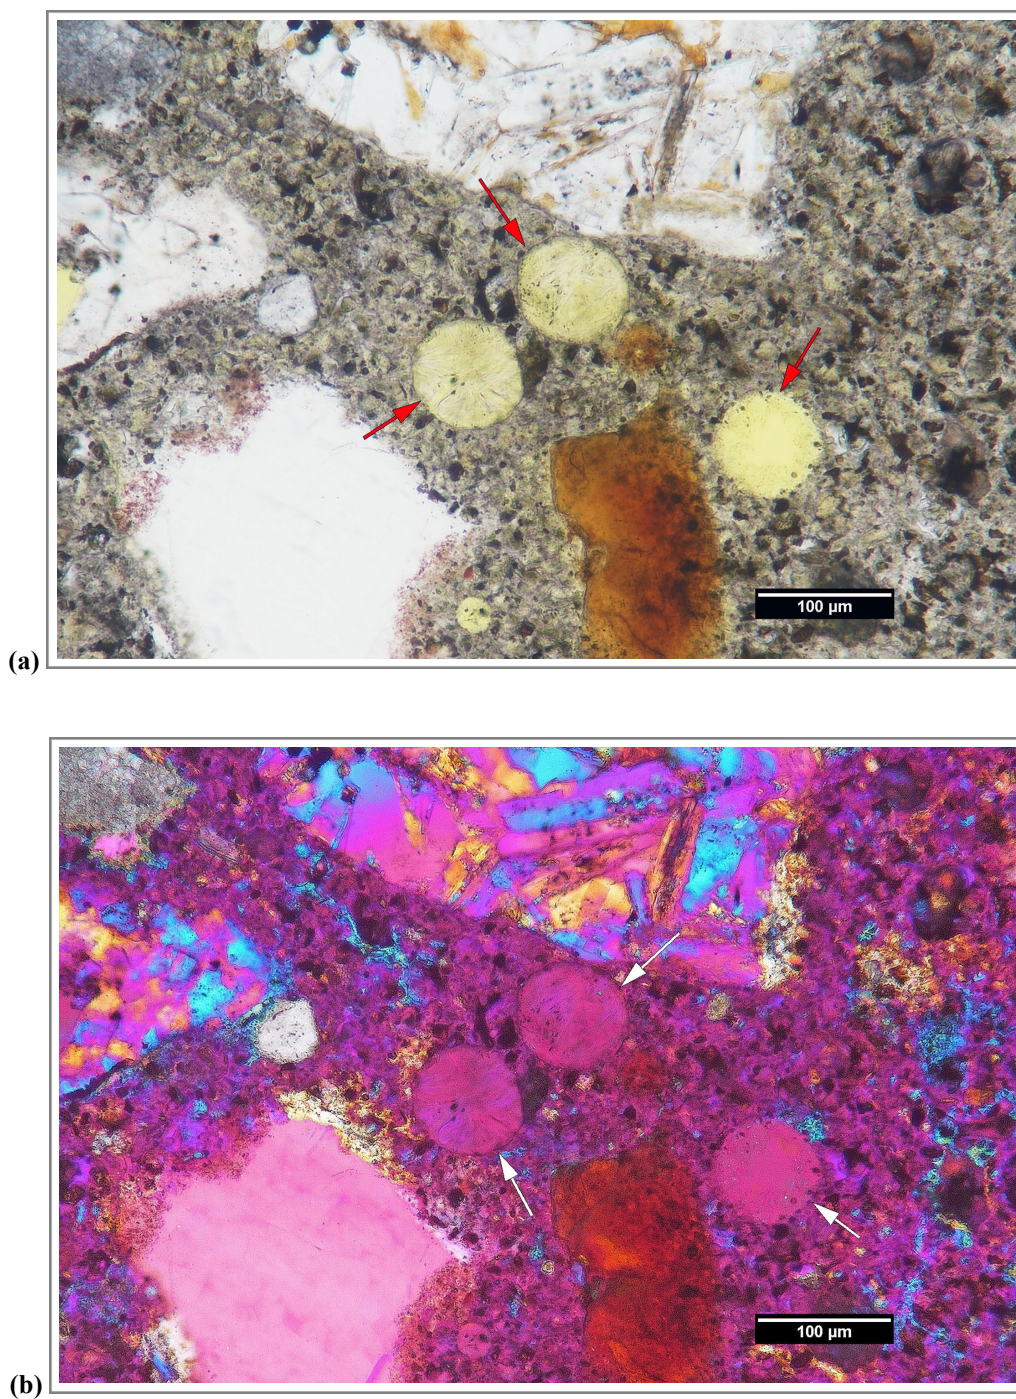
Figure A16. Transmitted light photomicrographs of thin section showing deposits of ettringite in voids (arrows) in (a) plane-polarized light and (b) cross-polarized light with the gypsum plate inserted.

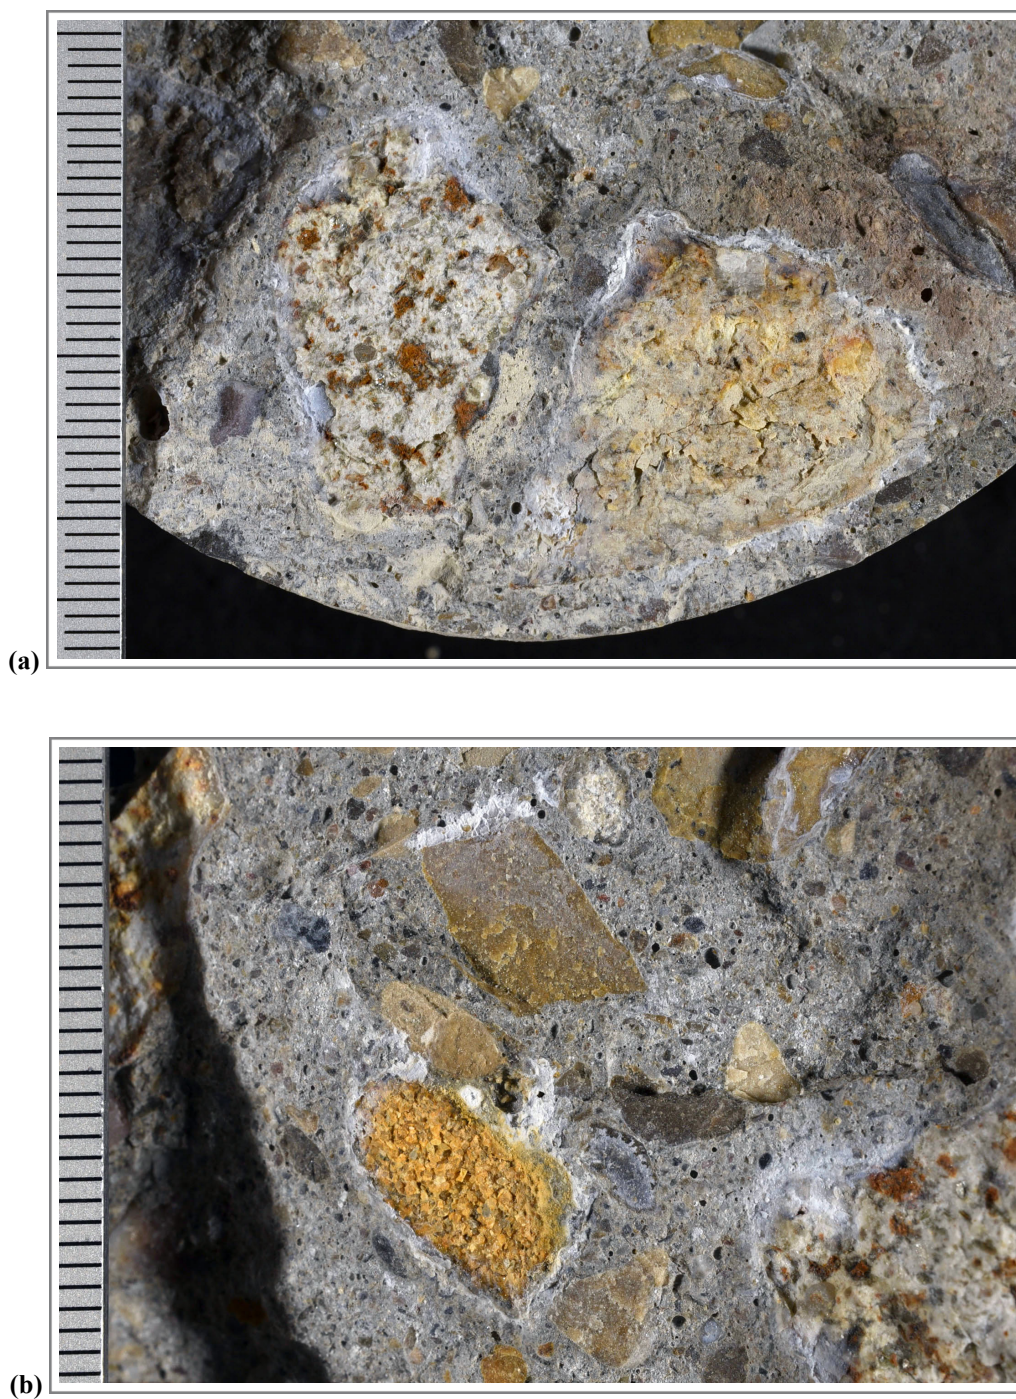
Figure A17. Photographs of the inner fracture surface showing detail of gel deposits around aggregate particles. Scale in millimeters in both photographs.
